***REGULAR HISTORIC PRESERVATION COMMISSION MEETING
AGENDA***

TO: Historic Preservation Commission
FROM: William Reis, Senior Planner
DATE: October 28, 2025
RE: Application for Alteration of a Designated Historic Property located at 433 S 1st St

Memo: Narrative Hotel Alia Hotel and Spa
Date: October 7th, 2025
Project: City of Montrose Historic Preservation Commission

Site Visit Date: June 27th, July 1st 2025
Weather: Sunny, 85-90 degrees.
Report by: Timothy Stroh AIA (TS)
Report Date: September 19th, 2025

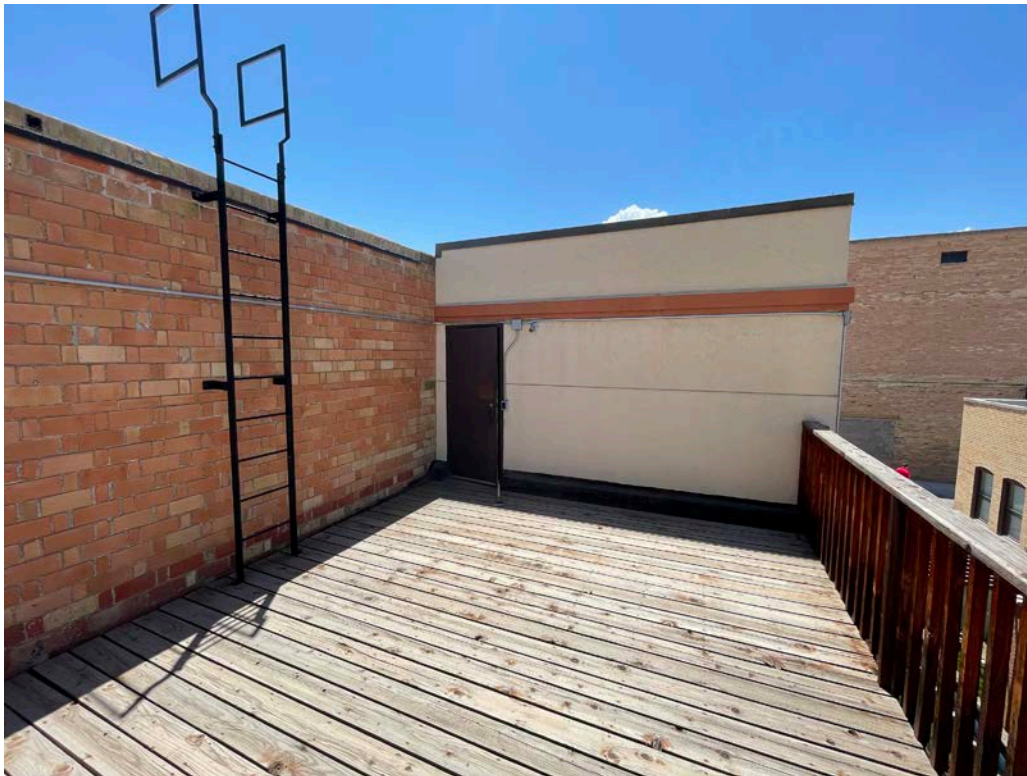
Photo 35: View west, second floor roof deck. Stucco wall represents western section of building.

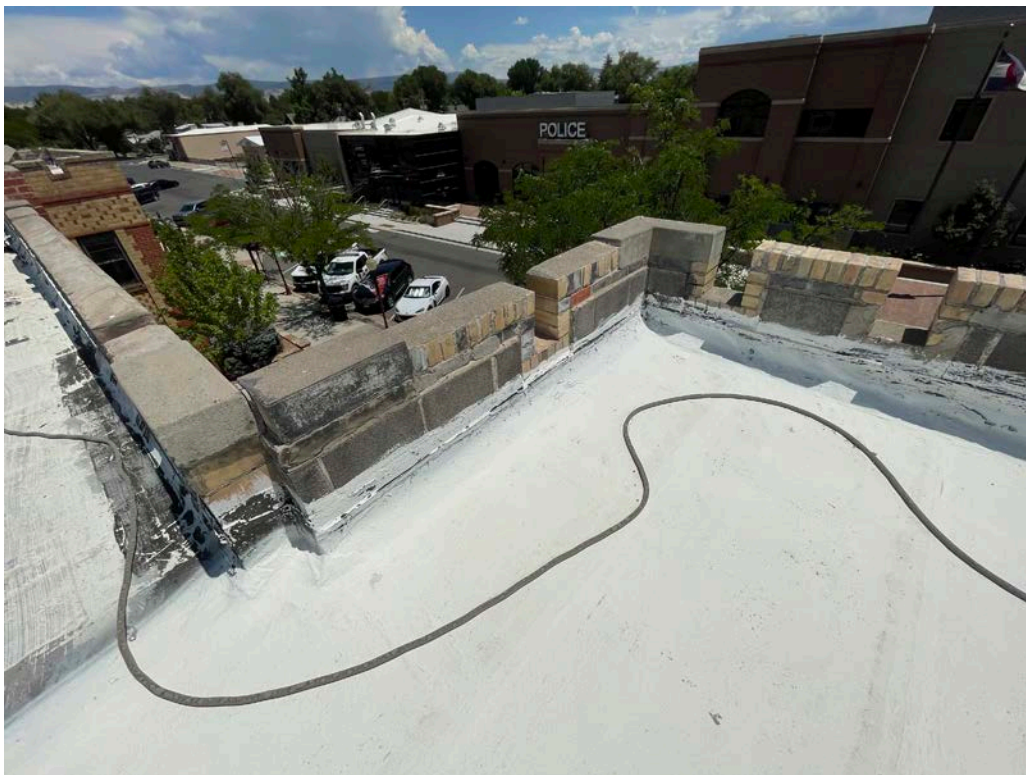
Photo 37: Parapet, south side of building at original building parapet (left side) meeting western section of building parapet and where bricks were reused. Newer parapet has larger cinder or CMU type blocks.

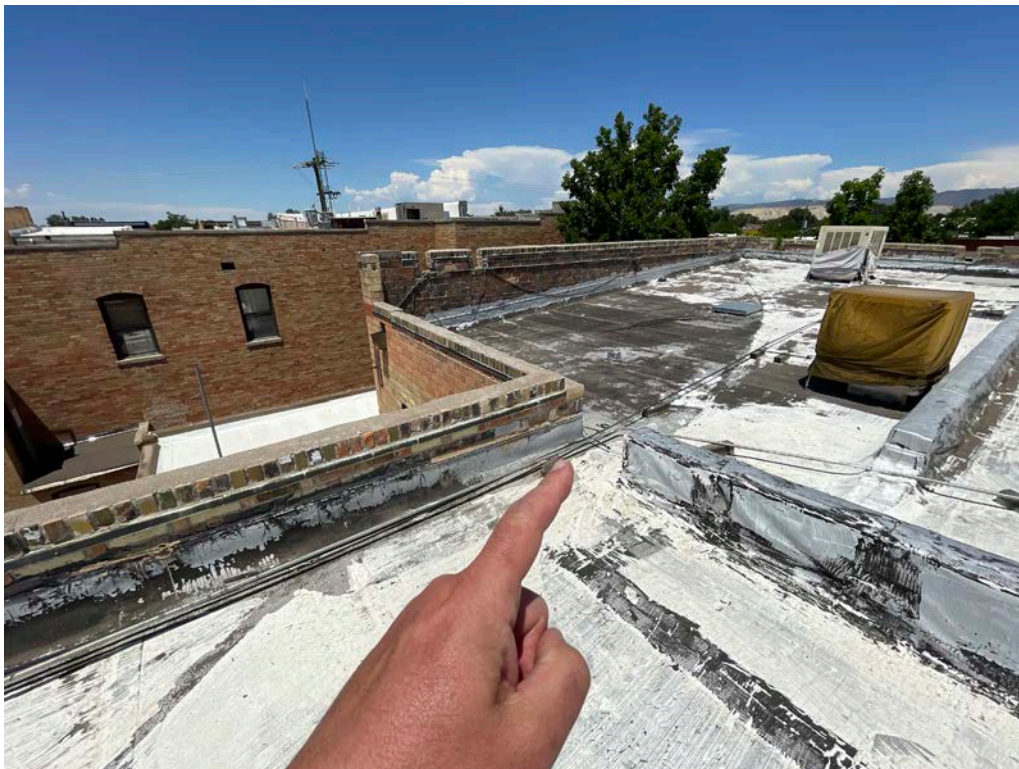
Photo 39: Low point for primary roof to drain. Water then moves north to scupper/drain.

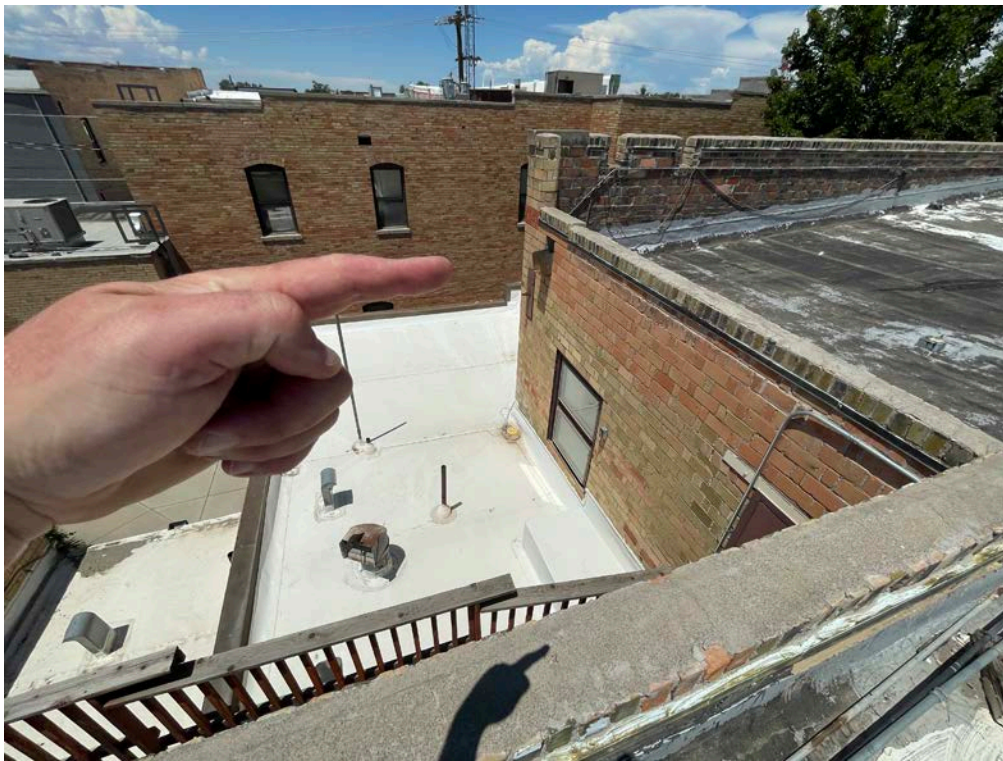
Photo 40: Overflow scupper, northwestern portion of eastern 2 story building. This is primary scupper for 1927 building.

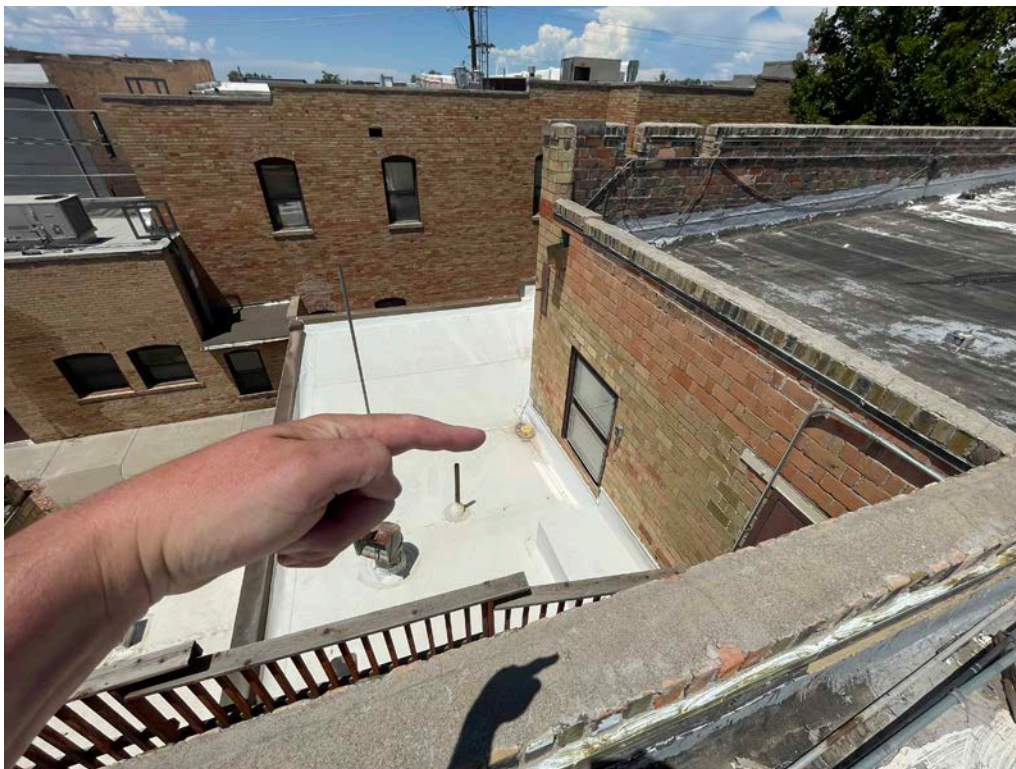
Photo 41: 1 story building roof drain, below the scupper.

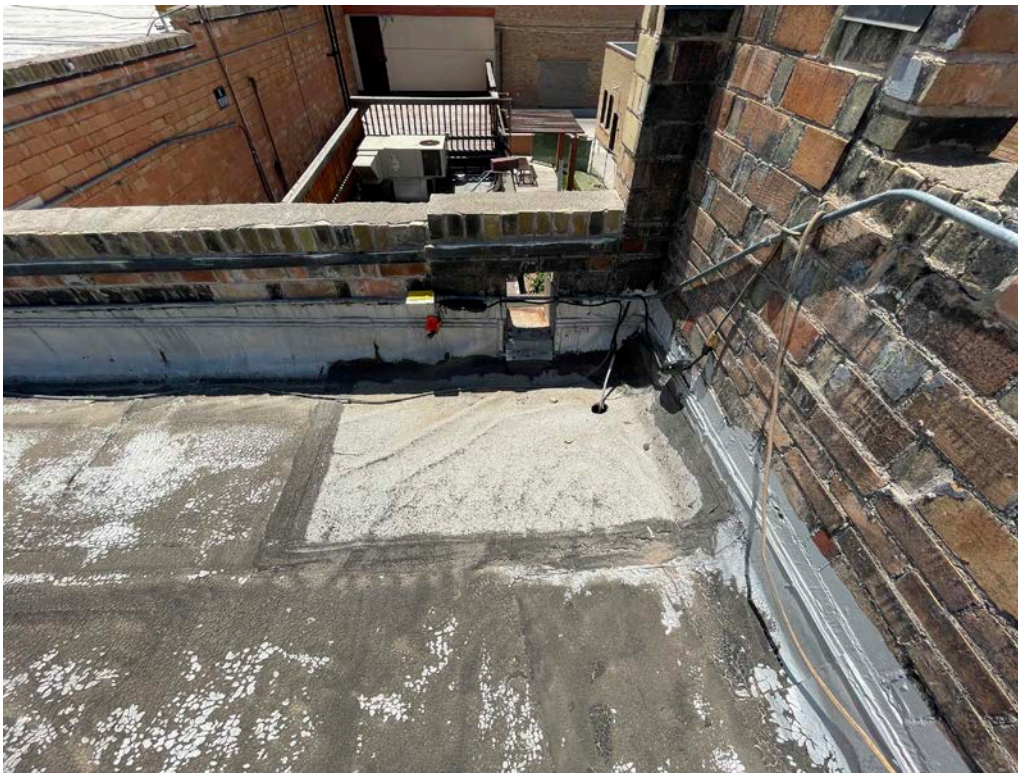
Photo 42: Northwestern corner of second story roof, backside of roof scupper. Roof drain is small hole with heat tape. Center right of picture. This appears to drain the entire 1927 section of second story roof. Western section of roof over 2 story, drains to the west.

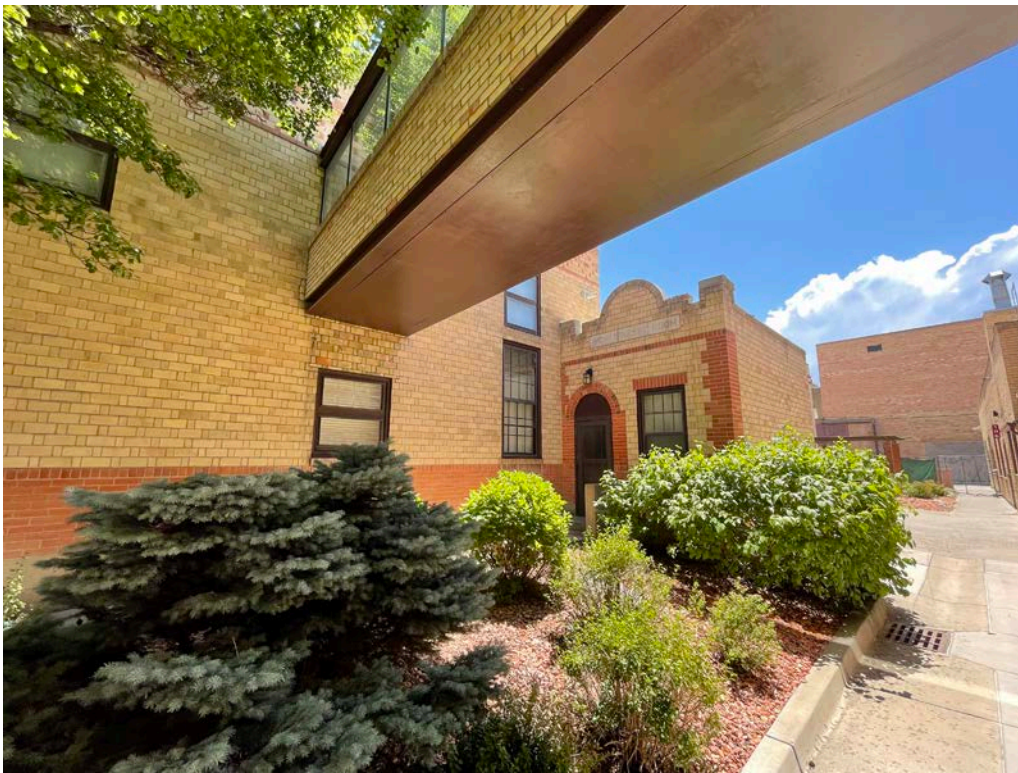
Photo 44: View southwest, sky bridge above, north exterior elevation, historic entry point to restrooms.

The second floor bridge connecting the City Hall and The Annex, which is best observed from the east elevation, believed to be built in 1989 (unable to find exact date information), will be removed. Masonry walls and openings on either end will be restored to the original configuration and design of materials following the Standards. (See dwg A5)

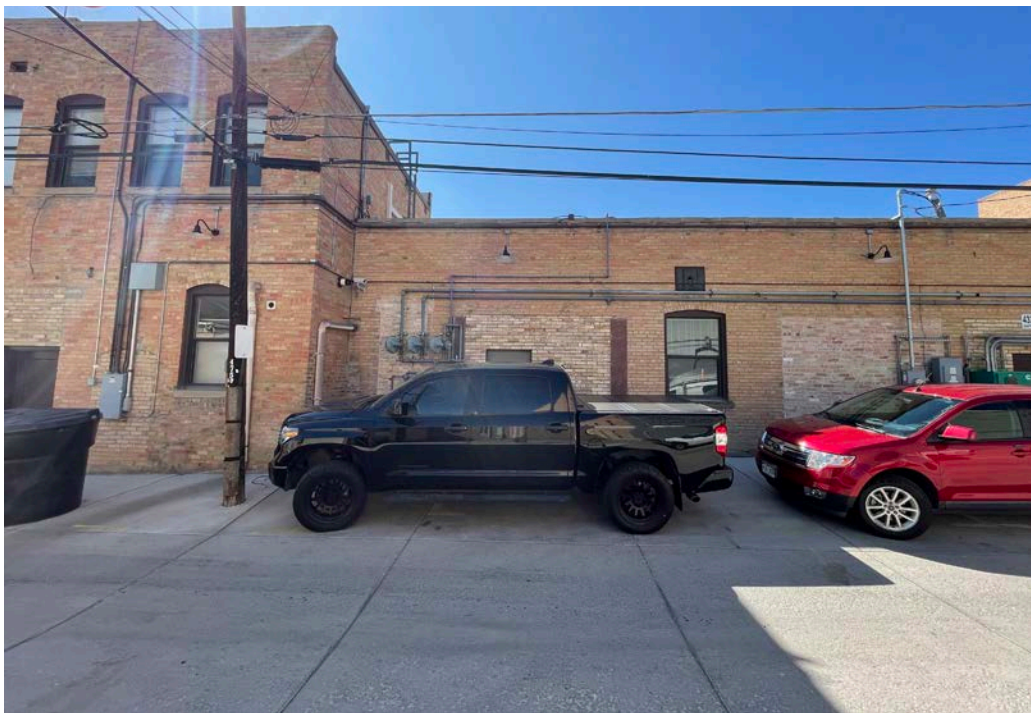
Photo 83: Annex north elevation, center section, step down from 2 story to 2 story.

The 1 story area of the building continues approximately 40' before the property ends and the approximately 35' of the City of Montrose IT building begins. This exterior area of the building will have all historic exterior elements rehabilitated and repaired following the Standards. This includes the masonry, windows, doors. No changes to the current exterior envelope of this building are expected. The roof structure will remain in this area and be incorporated into the future new work.
